# Glen Canyon Dam Is Broken

by John Weisheit

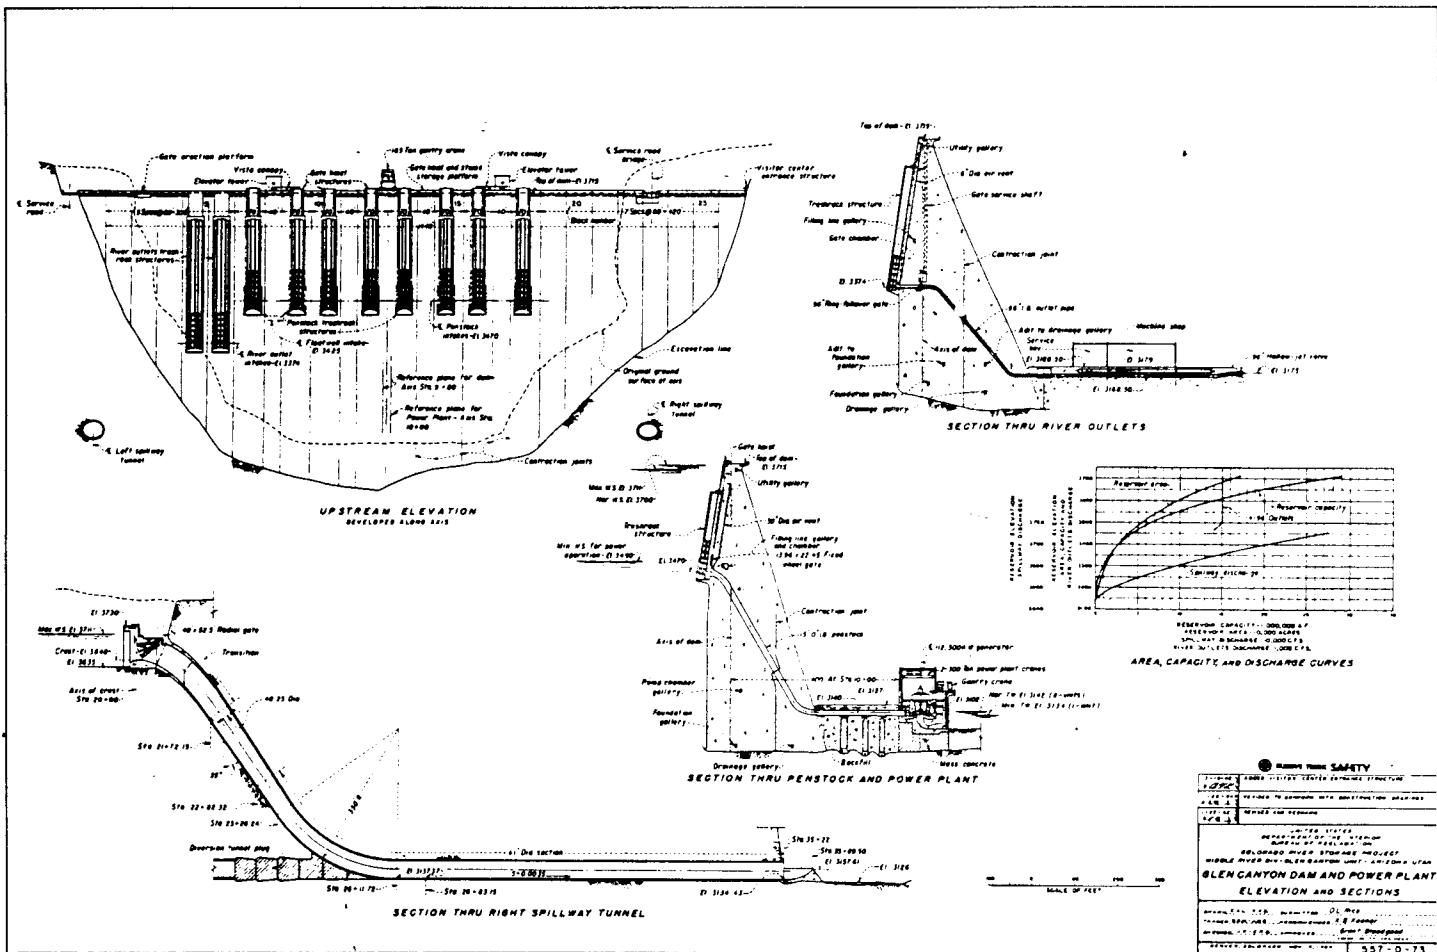
If 3065 feet asl is the elevation at the heel of the dam, what feature is constructed at 3115 feet asl? I looked at the schematic diagrams and found a startling answer. 3115 feet asl puts you about 20 feet under the right spillway, where you will also find the concrete plugs that seal-off the original diversion tunnel. During construction this tunnel was not used to divert the normal flow of the Colorado River; being built at a higher elevation, it was used only to handle the top peak of the snowmelt.

Glen Canyon Dam and Powerplant. Elevations and sections. Courtesy of the Bureau of Reclamation.
