THE CHANGING RAPIDS OF THE COLORADO RIVER Capsize Rapid (Rapid 15)

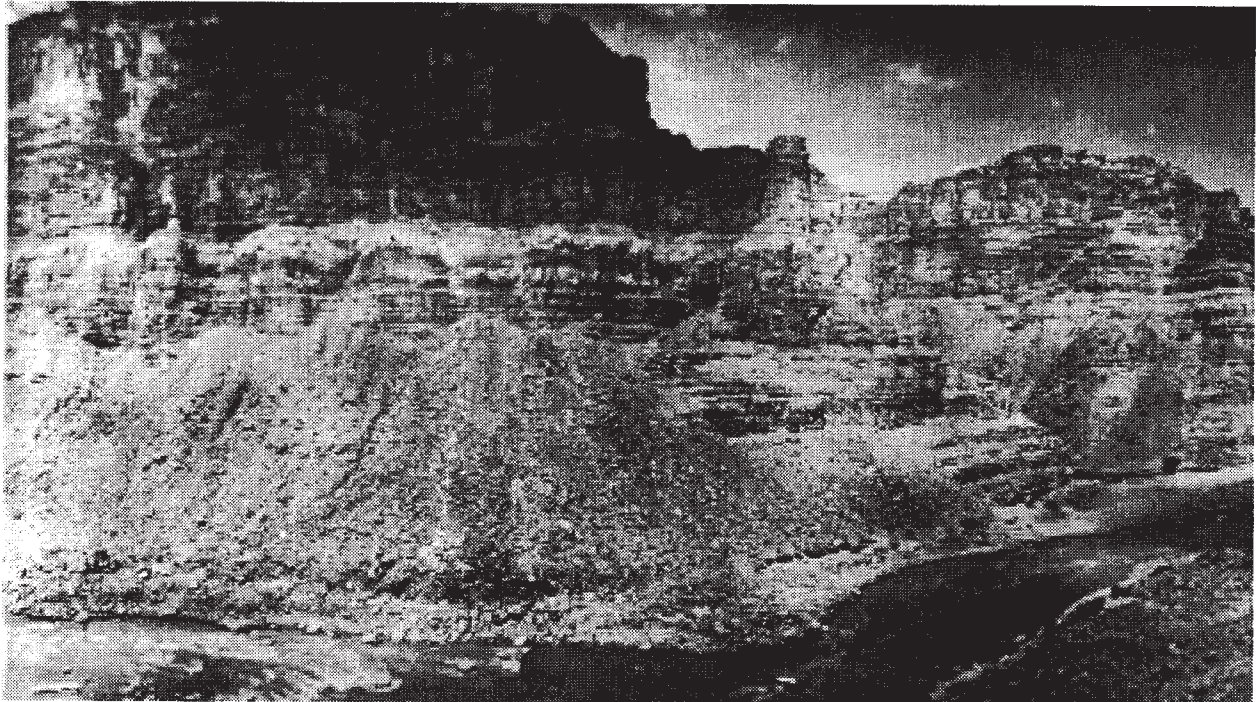
Eugene C. LaRue, the controversial hydrologist with the USGS river trips between 1921 and 1923, climbed high above Rapid 15 to take two panoramic photographs of Mile Long Rapid. This is a cropped section of one of the panoramas showing the river from Range Canyon (Rapid 13) to Capsize Rapid (LaRue 96, courtesy of the U.S. Geological Survey Photo Library).

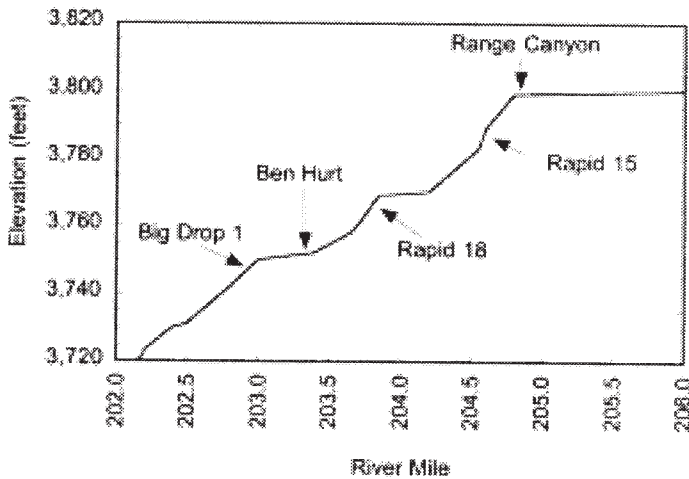
The longitudinal profile of Cataract Canyon from Lake Cataract to Big Drop 2, from the 1921 USGS survey data. The profile starts in Lake Cataract (on right) and ends in the Big Drops (on left).

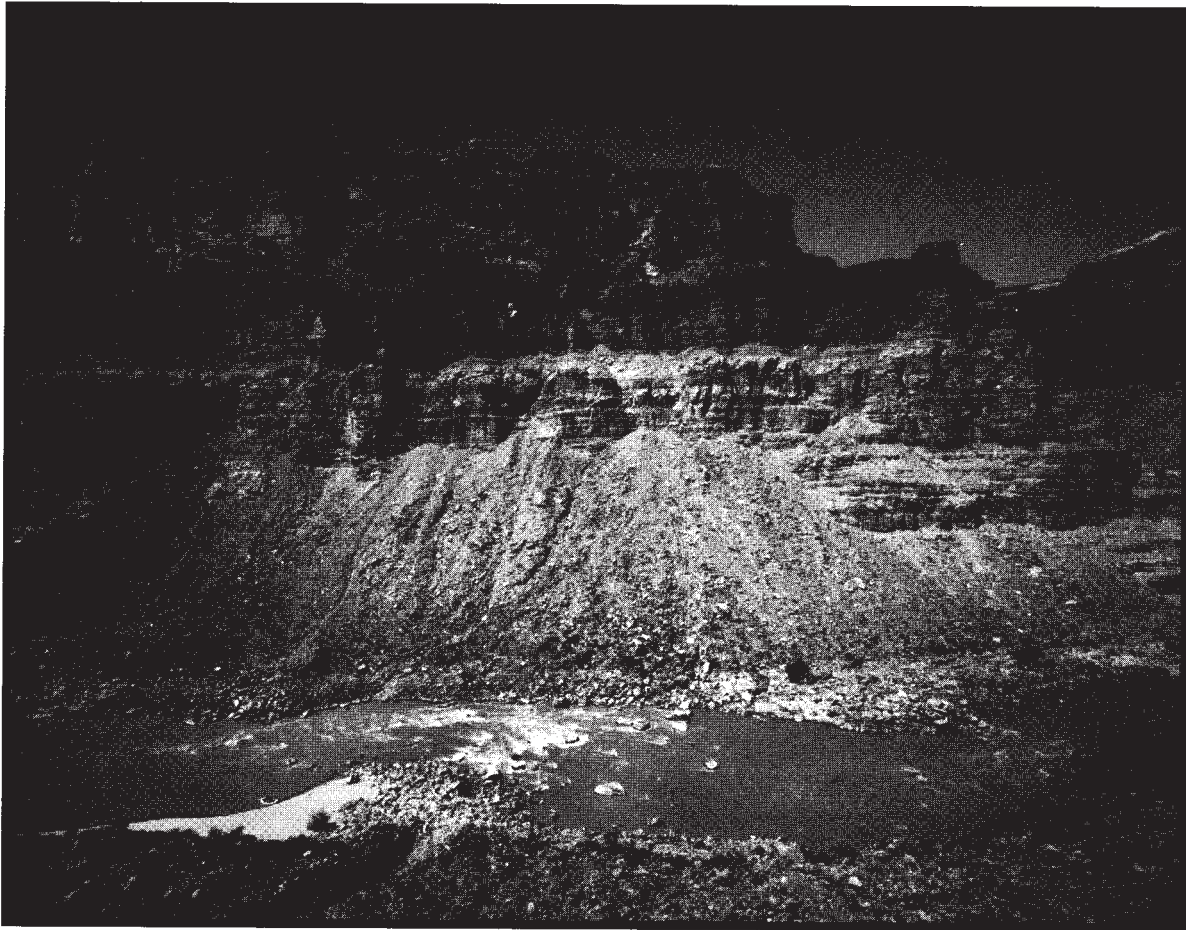
B. (March 31, 1994). Panoramic photographs are difficult to match, and this view is the left half of A., showing Rapid 15 and its debris fan. Two debris flows aggraded the debris fan after this photograph was taken (Gary Bolton, Stake 3080a).

The left side is a completely different story, because rocks are pushed into the river by debris flows from a canyon that is a little larger than it looks from the river. That canyon has flashed slurries of debris several times in the last century, including a relatively large event between 1921 and 1964 and smaller debris flows in September 1997 and 1999. As a result, the little debris fan on river left has risen as much as 6 feet and the rapid is a little narrower than it used to be, particularly at high water. All the low-water obstacles in the rapid have been there

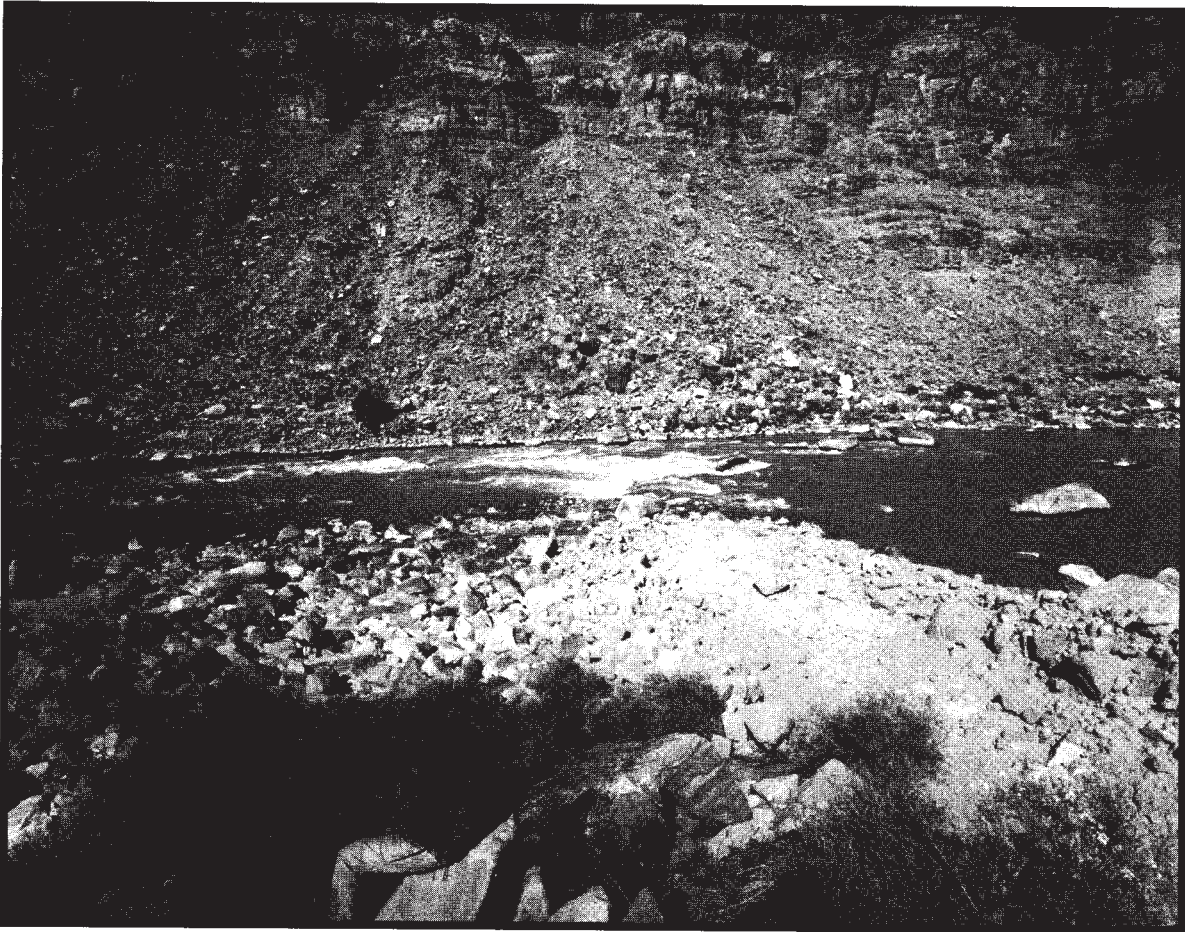
Rapid 15 from River Left. (October 17, 1999). A monitoring photograph showing the combined effects of the 1997 and 1999 debris flows on the left side of Rapid 15 (Dominic Oldershaw, Stake 3922).
