On March 8th, 2005, Albert Reichert, John Dohrenwend and John Weisheit did a photographic and GPS reconnaissance of Glen Canyon below Hite Marina. Lake Powell has been greatly diminished in size due to the effects of sustained drought and unrelenting water consumption by farms and cities. The Colorado River now flows freely on top of its sediment deposits, which have been accumulating in Lake Powell reservoir since 1963. These sediment deposits on the Colorado River are currently 35 miles in length, and can be found in lower Cataract, Narrow and upper Glen canyons. The sediment deposits end about five miles below the now defunct marina at Hite.

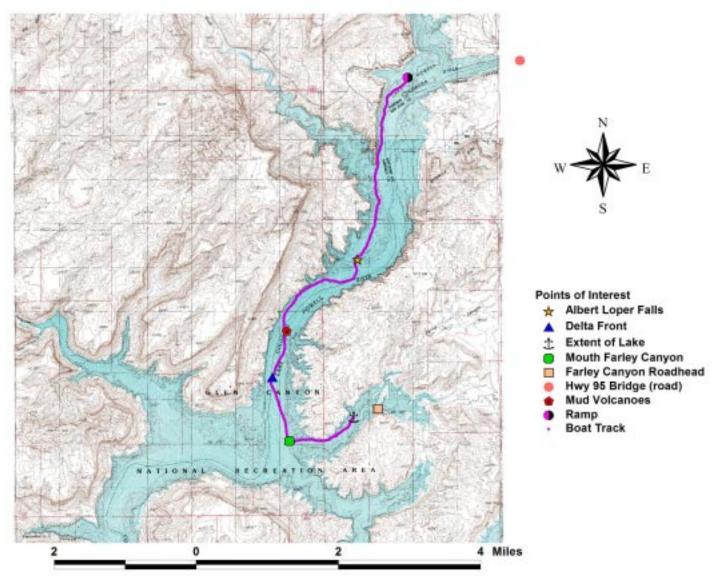
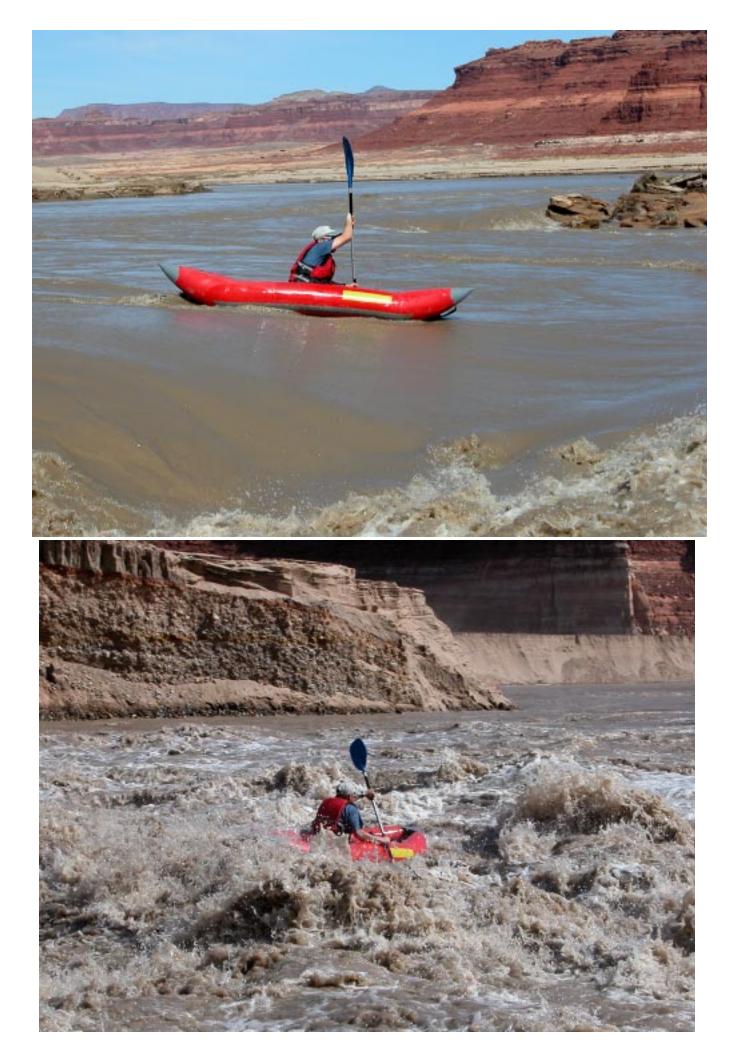
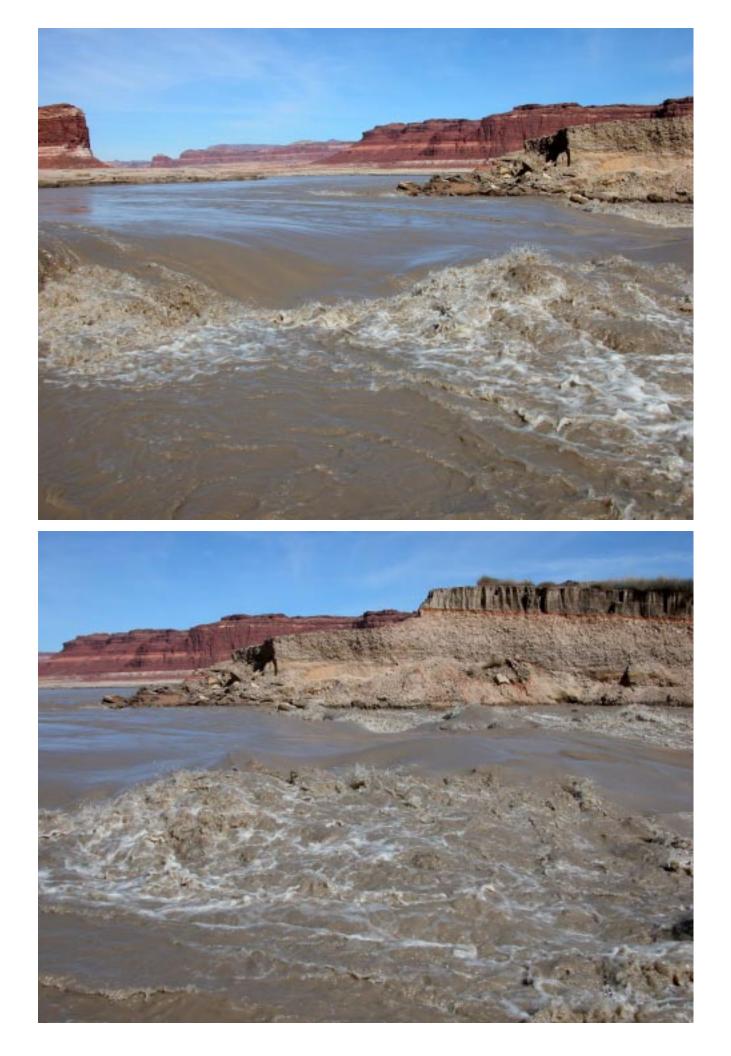
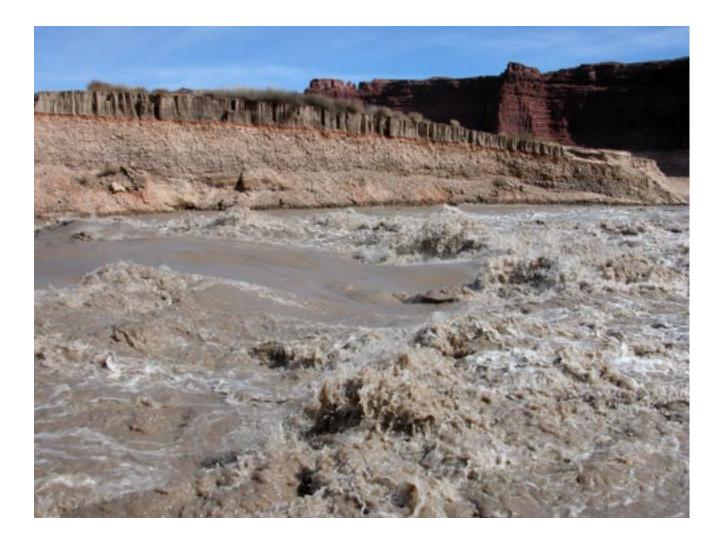
Since the sediment deposits have buried bedrock formations, such as the divides between side canyons and the flat benches that were once canyon rims, the Colorado River, as it cuts down into the soft sediment, eventually strikes a bedrock formation of old and a rapid is soon created. As the reservoir continues the drop and the Colorado River continues to chew the sediment away, the rapid will become quite steep and eventually forms a waterfall.

The new Glen Canyon rapid, as photographed below, is between North Canyon and Farley Canyon.
